Section Corner restoration and the advancing technology of measuring

By: Warren Delles, Mille Lacs County Surveyor

Date: February, 2014

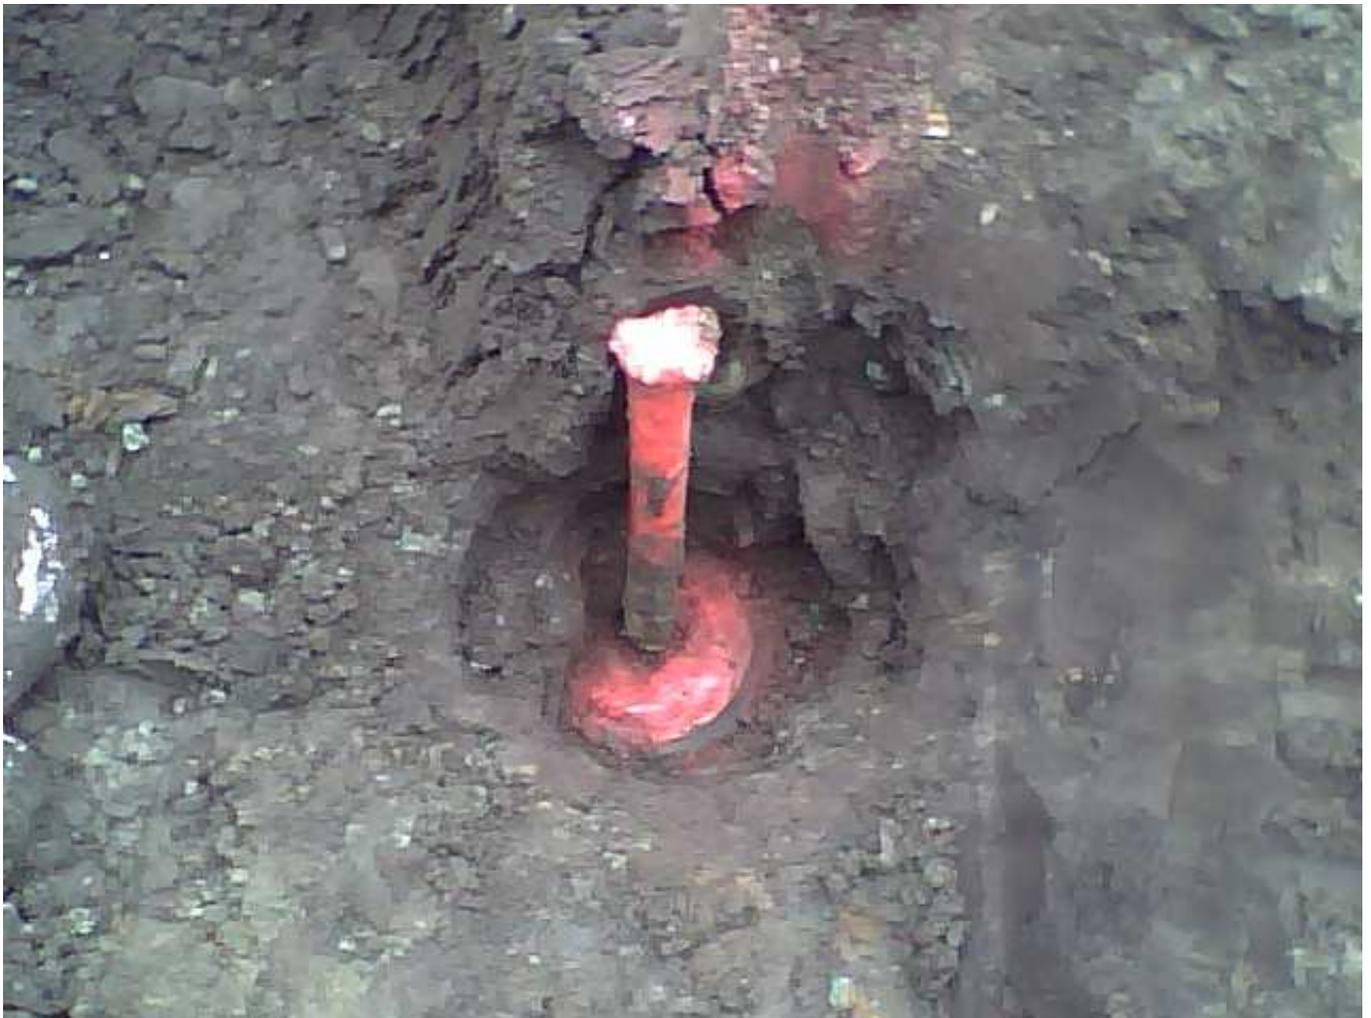
CERTIFICATE OF LOCATION OF GOVERNMENT CORNER

North Quarter Corner of Section 28, Township 37 North, Range 27 West, 4th P.M.
County of Mille Lacs, State of Minnesota.

On May 10, 2010, a 1 1/2" solid iron post along with a grinding wheel at the base of solid iron post was found approximately 5' below the gravel road surface. The iron post and 'grindstone' are consistent with monuments described in historic survey records. Set a 3/4" iron pipe with plastic cap inscribed 'RLS 41890' directly above found monuments approximately 0.3 feet below gravel road surface.

A Certificate of Location of Government Corner was prepared (and is now on file as document number 1561) for the 'grindstone' found at the North Quarter corner of Section 28.

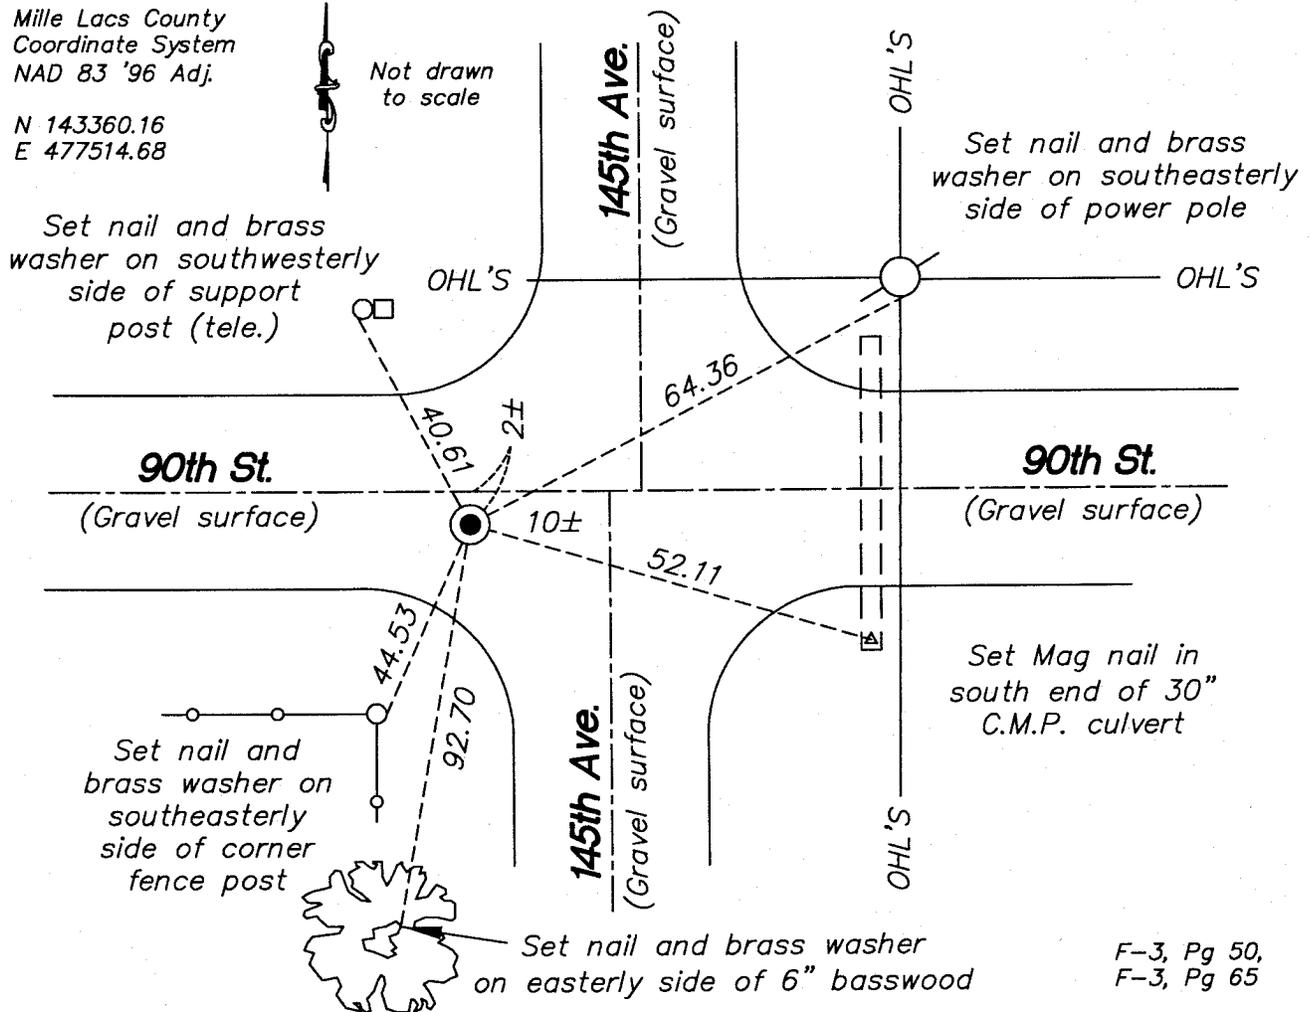
Mille Lacs County
Coordinate System
NAD 83 '96 Adj.

N 143360.16
E 477514.68

Not drawn
to scale

Approximately 5 feet below the gravel road surface, the top of a solid 1 ½ inch iron post was encountered. Excavation surrounding the found iron post continued, and at the base of the pointed solid iron post, a grinding wheel was located. The position of the square hole in the center of the grinding wheel was obtained, and a photograph of the monument was taken for the record. The photograph is attached to the end of this document.

The grindstone and 1 ½" iron were left in place (as found). The gravel road was repaired, and a ¾" iron pipe with a plastic cap inscribed 'RLS 41890' was placed directly above the found 'grindstone' approximately 0.3' below the gravel road surface.

Approximately 5 feet below the gravel road surface, the top of a solid 1 ½ inch iron post was encountered. Excavation surrounding the found iron post continued, and at the base of the pointed solid iron post, a grinding wheel was located. The position of the square hole in the center of the grinding wheel was obtained, and a photograph of the monument was taken for the record.

The monuments were left in place (as found). The gravel road was repaired, and a ¾" iron pipe with a plastic cap inscribed 'RLS 41890' was placed directly above the found 'grindstone' approximately 0.3' below the gravel road surface.
